# **Tangy IV Wind Farm Section 36C Variation**

## **Technical Appendix 9.1: Private Water Supply Assessment**

# Technical Appendix 9.1 PWS Assessment

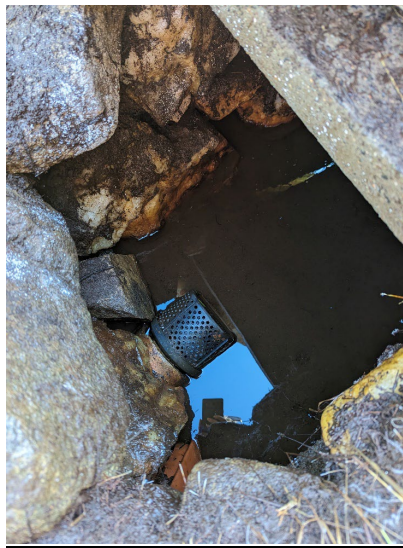
**Plate 1 Tangytavil /Lagaltarve Farm PWS 02. Collection tank/chamber of collector pipes from a spring or shallow groundwater (taken February 2026).**

- 1.3.3. *Impacts to Quality* – Potential sources of contamination include accidental spillages associated with the works which may migrate towards PWS 02. As the borrow pit is upgradient from the works it is possible that there may be a significant level of impact without mitigation. Keyhole felling works may also cause mobilisation of soils and sediment which has the potential to migrate via surface run-off. However, impermeable layers within the surrounding till and peat will likely help impede the amount of contaminants able to reach the supply source, and any effect is only likely to occur during the construction period involving the borrow pit, and during a very brief period for keyhole felling. Considering the relative distance of the PWS from the borrow pit, it is anticipated that with standard and embedded mitigation any impact to quality will likely have a small extent, magnitude and likelihood. There are also no long term or cumulative impacts predicted.

- 1.3.4. *Impacts to Quantity* – Localised dewatering likely required for the borrow pit within superficial deposits could cause a localised drop in the surrounding water table which could cause a drop in the water level of the PWS source. It is likely that any dewatering will only temporarily impact the PWS, and level monitoring will help observe any

significant impacts. However, there is a small degree of uncertainty as there is limited information on the aquifer properties and flow directions.

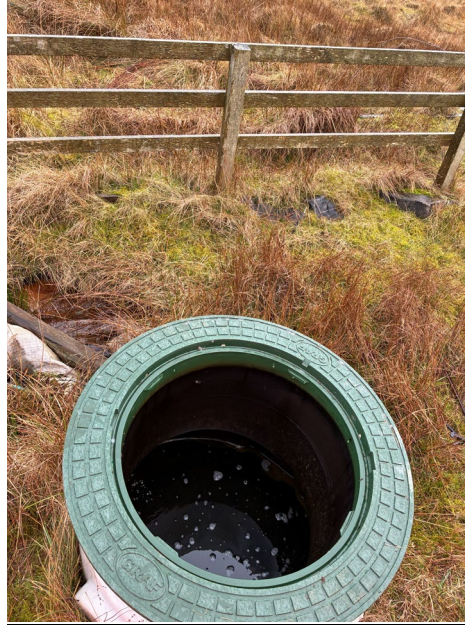
**Plate 2 Tangy Farm. Groundwater spring on the existing Tangy Windfarm. Cylindrical plastic with a plastic lid and a metal covering (taken February 2026).**

- 1.3.7. *Impacts to Quality* – Potential sources of contamination include accidental spillages associated with the works which may migrate towards PWS 13. Keyhole felling works may also cause mobilisation of soils and sediment which has the potential to migrate via surface run-off. Groundwater flow is likely to follow the topographic gradient south towards Tangy Burn rather than migrating cross-gradient towards the supply. The borrow pit is situated primarily on exposed bedrock, whereas the PWS is situated on till. It is not known whether the PWS draws its supply from perched water within the till or bedrock, however if from within the bedrock, the supply is at a greater risk of contaminants from the borrow pit which is also situated on the bedrock. Any effect however is only likely to occur during the construction period involving the borrow pit, and with standard and embedded mitigation any impact to quality will likely have a small extent, magnitude and likelihood. There are no long term or cumulative impacts predicted.

- 1.3.8. *Impacts to Quantity* – Localised dewatering likely required for the borrow pit could cause a localised drop in the surrounding water table within the bedrock aquifer, which could cause a drop in the water level of the PWS source, if this is within the bedrock or it is hydraulically connected. It is likely that any dewatering will only temporarily impact the PWS, and level monitoring will help observe any significant impacts. However, there is a small degree of uncertainty as there is limited information on the aquifer properties and flow directions.
