Project:	Cloiche Wind Farm	
Our reference:	408095	Your reference:
Prepared by:	K Young / K Munro	Date: 31/03/20
Approved by:	A Martin	Checked by: J Adams
Subject:	Borrow Pit Appraisal Report Rev D

As part of a review of the overall site layout for Cloiche Wind Farm, SSE Renewables have appointed Mott MacDonald to identify and appraise the proposed borrow pit (BP) locations for the Proposed Development (Site).

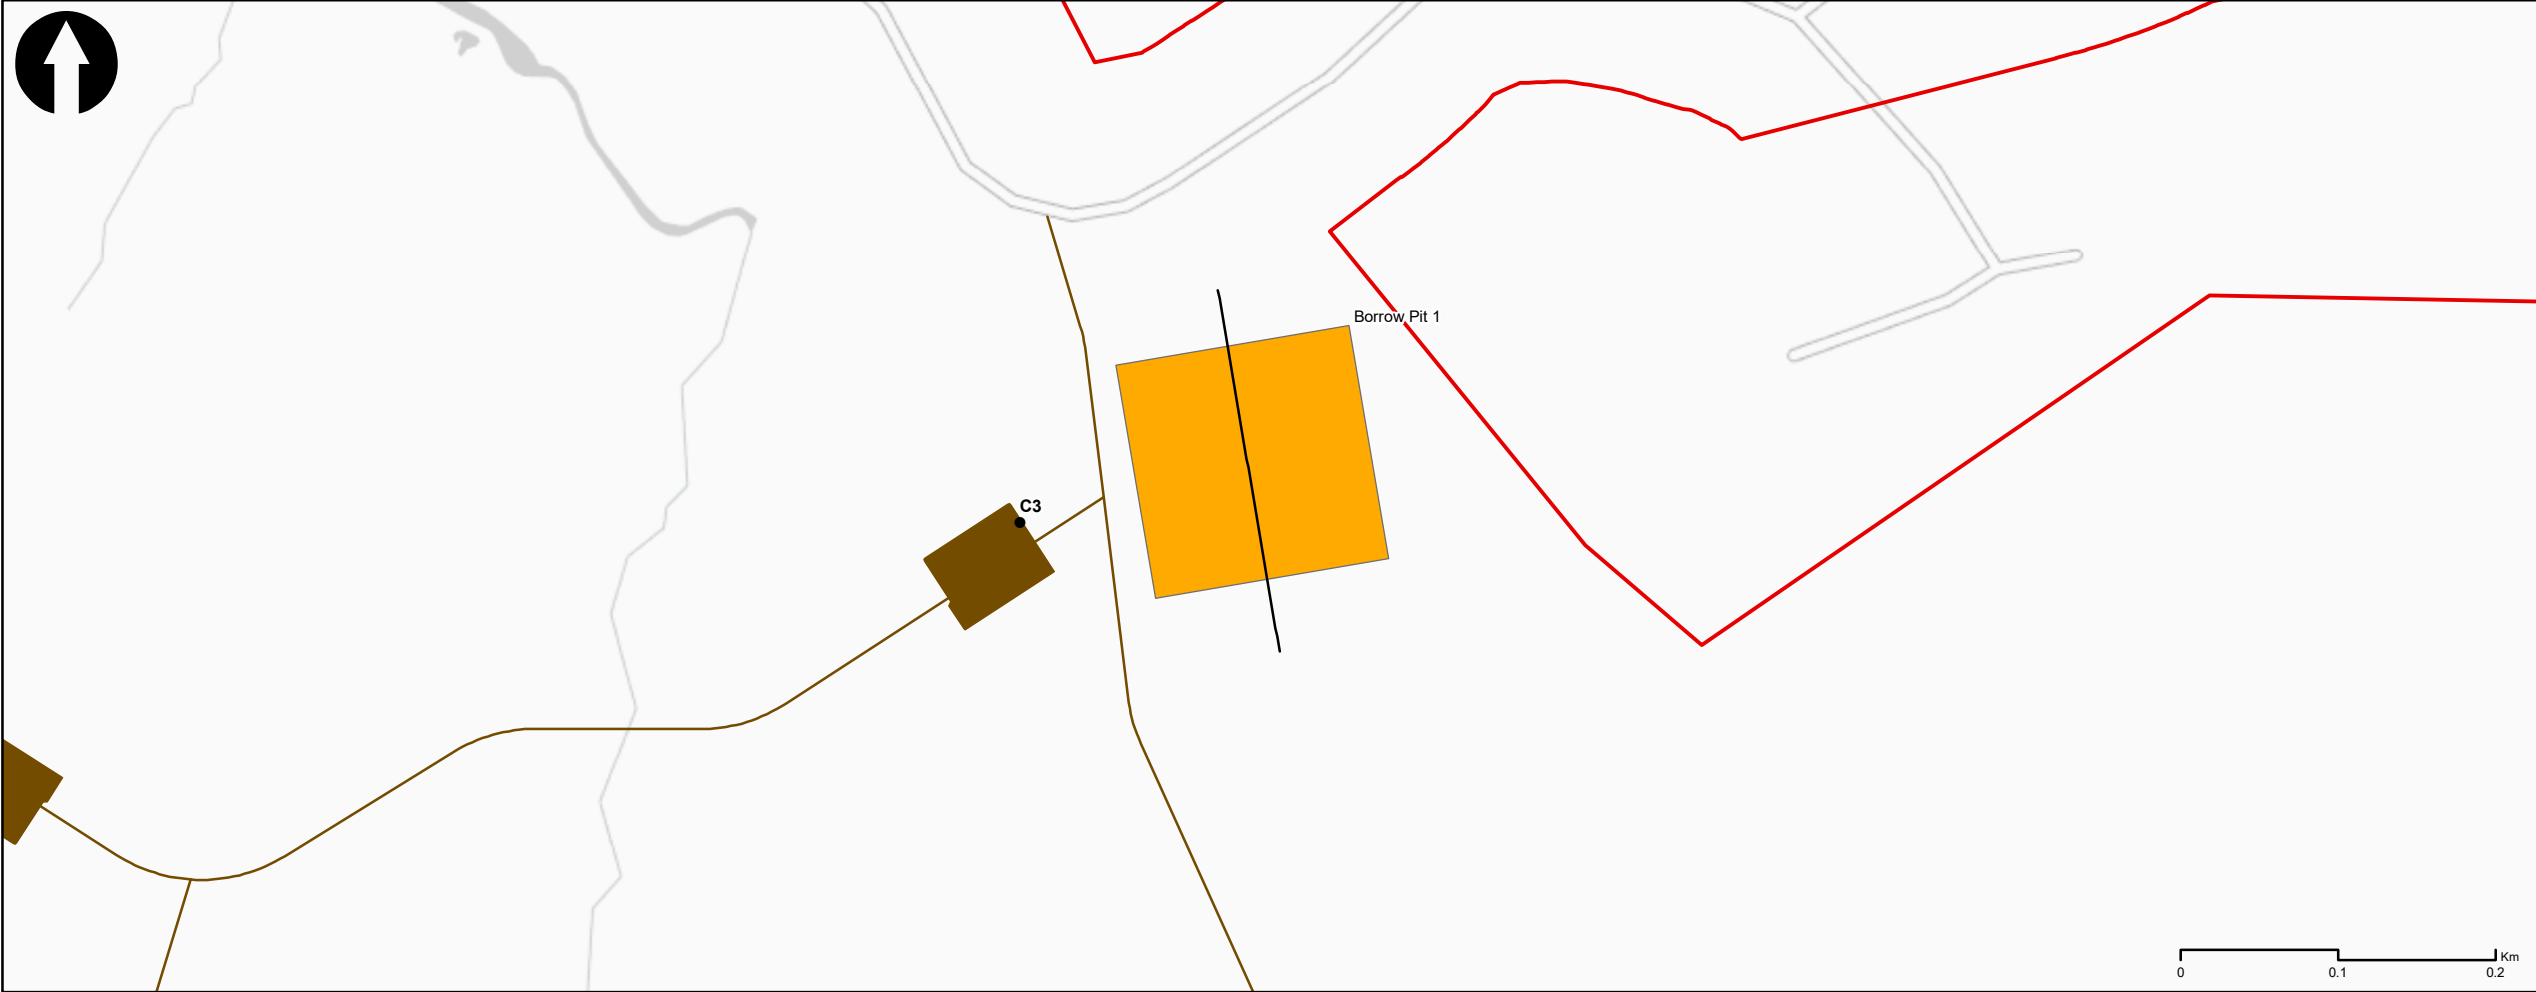
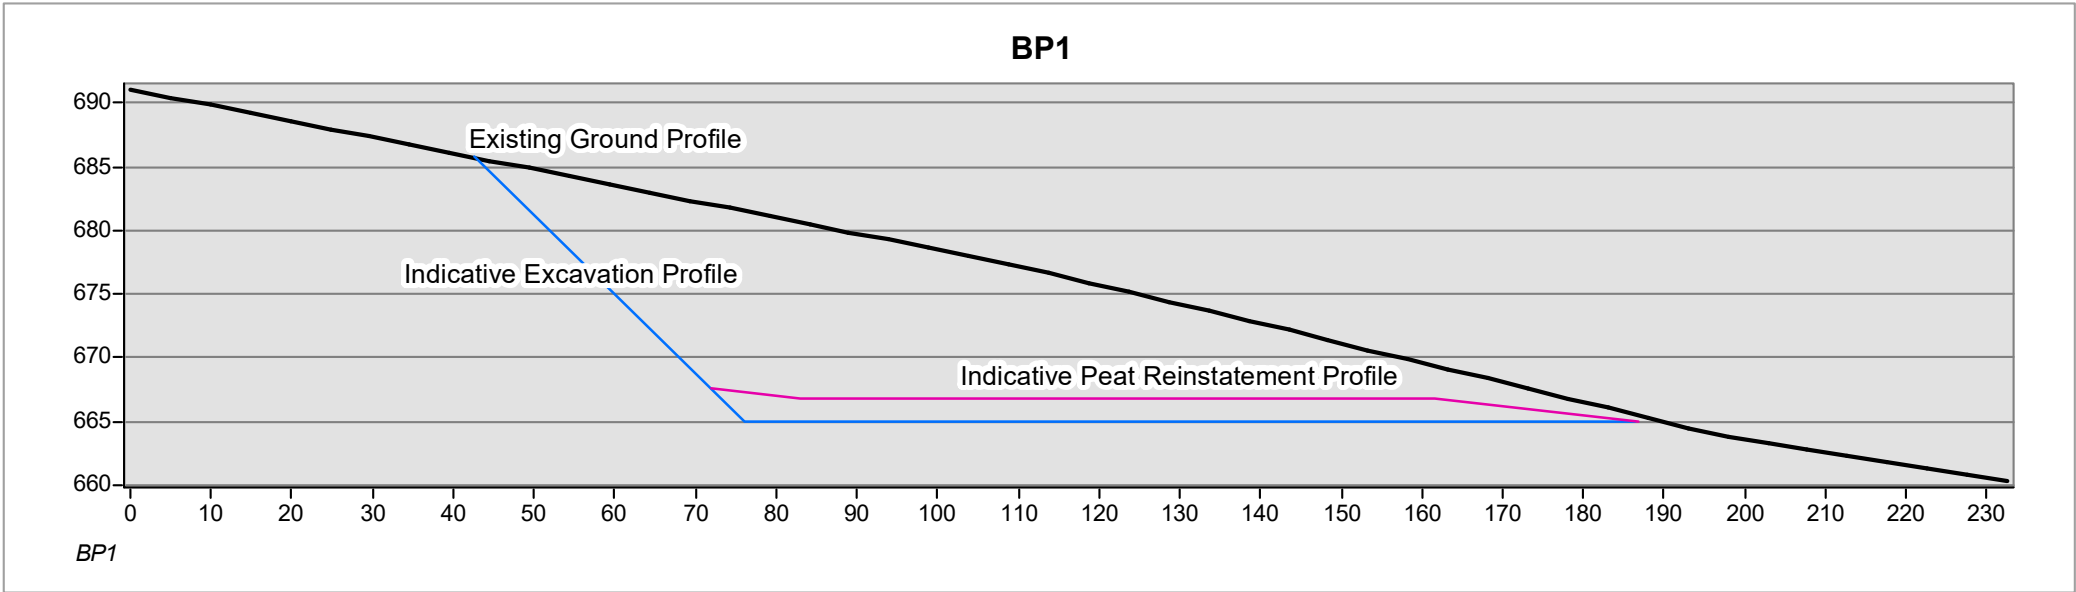
MMD-408095-DR-BP-GIS-001

Borrow Pit	Coordinates		Approx. Dimensions					Potential Volume Extracted (m3)	Potential Useful Aggregate	Geology
	Easting	Northing	Search Area (m2)	Width (m)	Length (m)	Max. Depth (m)	Footprint Area (m2)			
BP1	24811	80310	22,500	150	150	20	19,500	136,000	141,440	Psammite

- Overburden thickness is likely to vary at each borrow pit location.
- Anticipated aggregate volumes are shown on Figures A.2 to A.10, along with indicative sections through the proposed search areas.

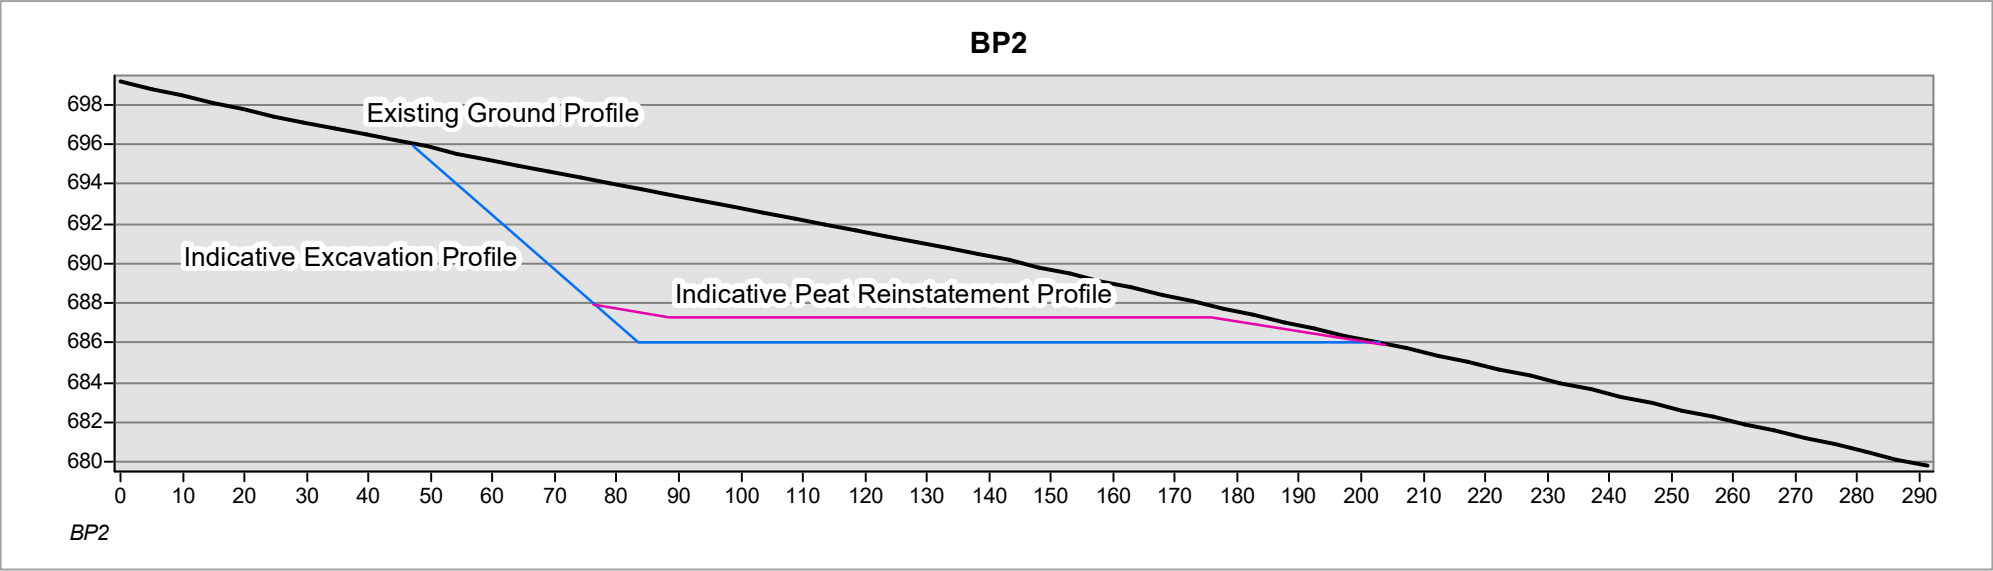
Drawing Number
MMD-408095-DR-BP-GIS-002

Borrow Pit	Coordinates		Approx. Dimensions					Potential Volume Extracted	Potential Useful Aggregate	Geology
	Easting	Northing	Search Area (m2)	Width (m)	Length (m)	Max. Depth (m)	Footprint Area (m2)			
BP2	24649	80243	22,500	150	150	8	21,300	75,000	78,000	Psammite

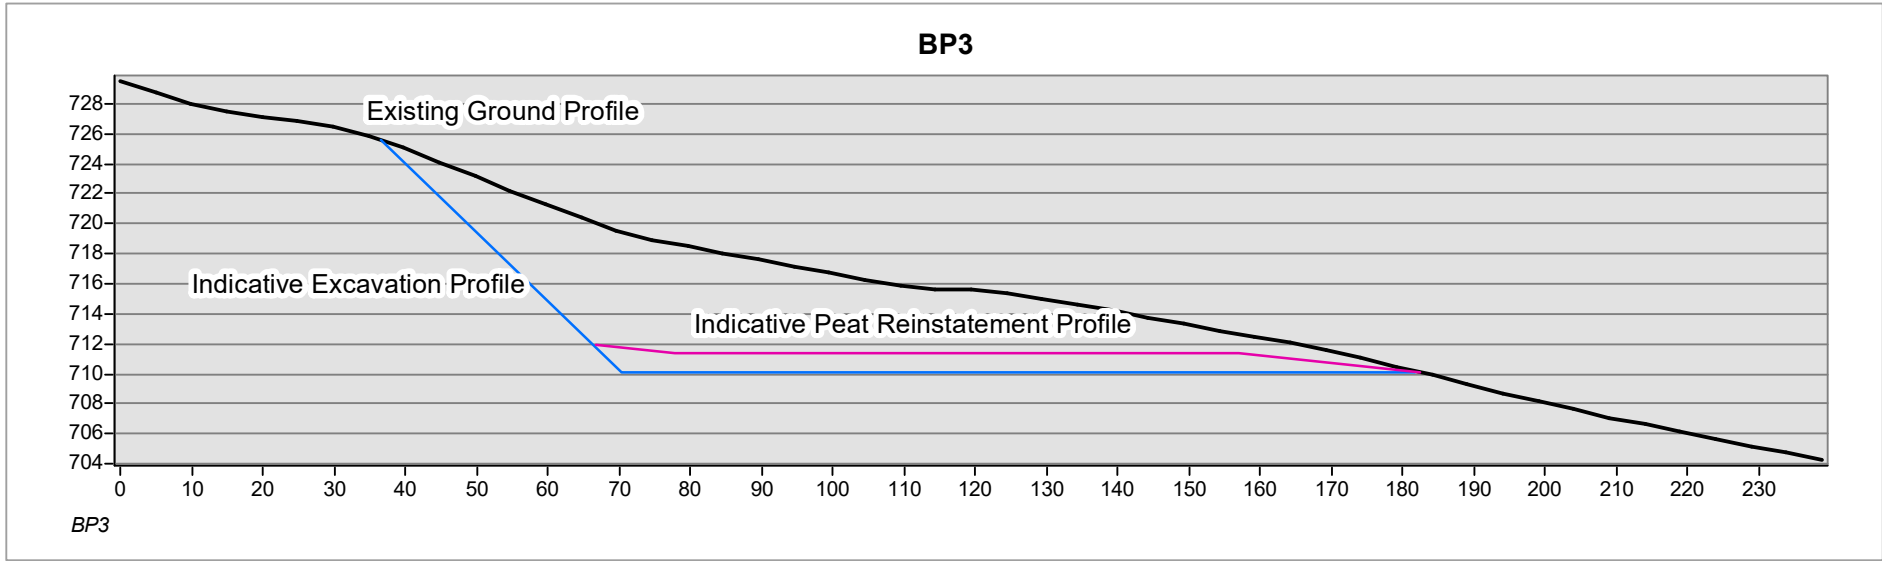
MMD-408095-DR-BP-GIS-003

Borrow Pit	Coordinates		Approx. Dimensions					Potential Volume Extracted (m3)	Potential Useful Aggregate	Geology
	Easting	Northing	Search Area (m2)	Width (m)	Length (m)	Max. Depth (m)	Footprint Area (m2)			
BP3	24930	80204	22,500	150	150	16	20,100	147,000	152,880	Granodiorite

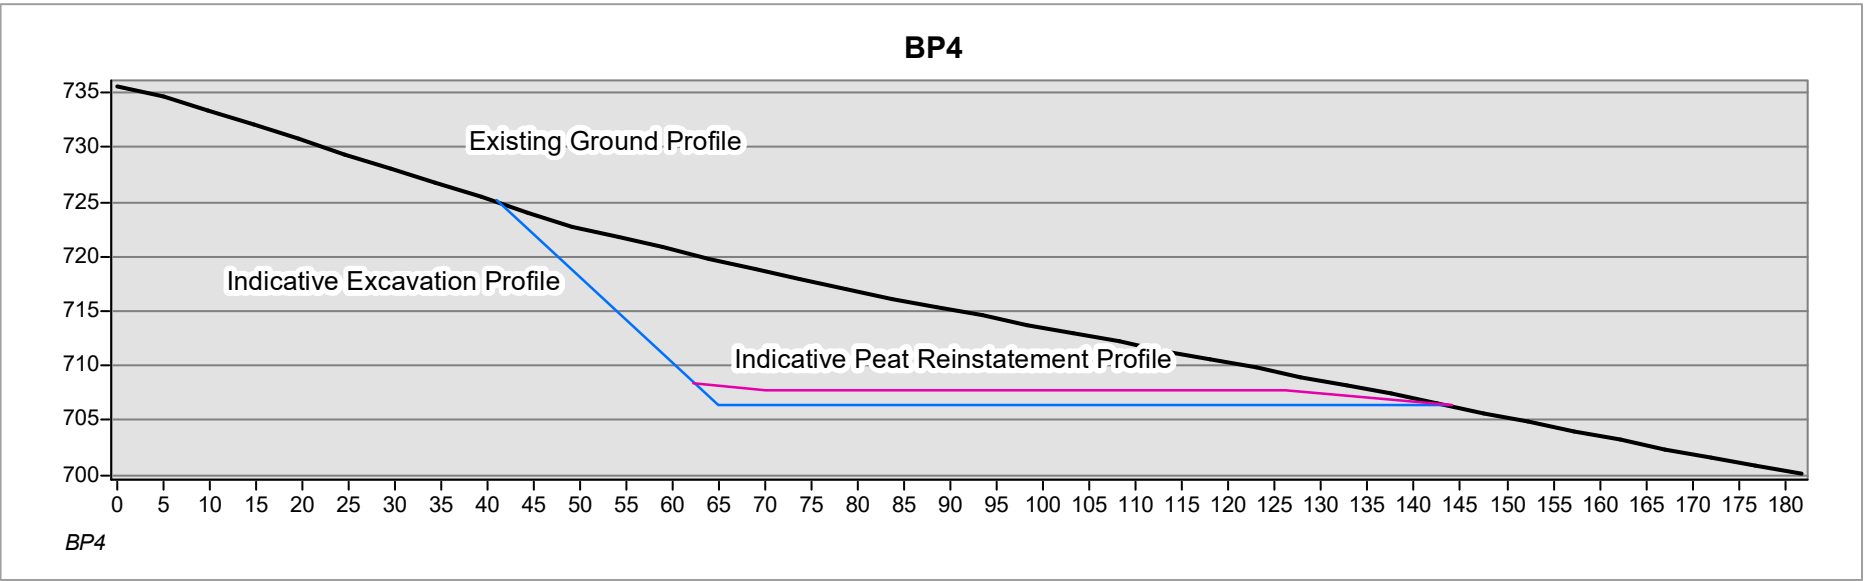
MMD-408095-DR-BP-GIS-004

Borrow Pit	Coordinates		Approx. Dimensions					Potential Volume Extracted (m3)	Potential Useful Aggregate	Geology
	Easting	Northing	Search Area (m2)	Width (m)	Length (m)	Max. Depth (m)	Footprint Area (m2)			
BP4	24750	80177	10,000	100	100	18	8,200	68,000	70,720	Semi-pelite

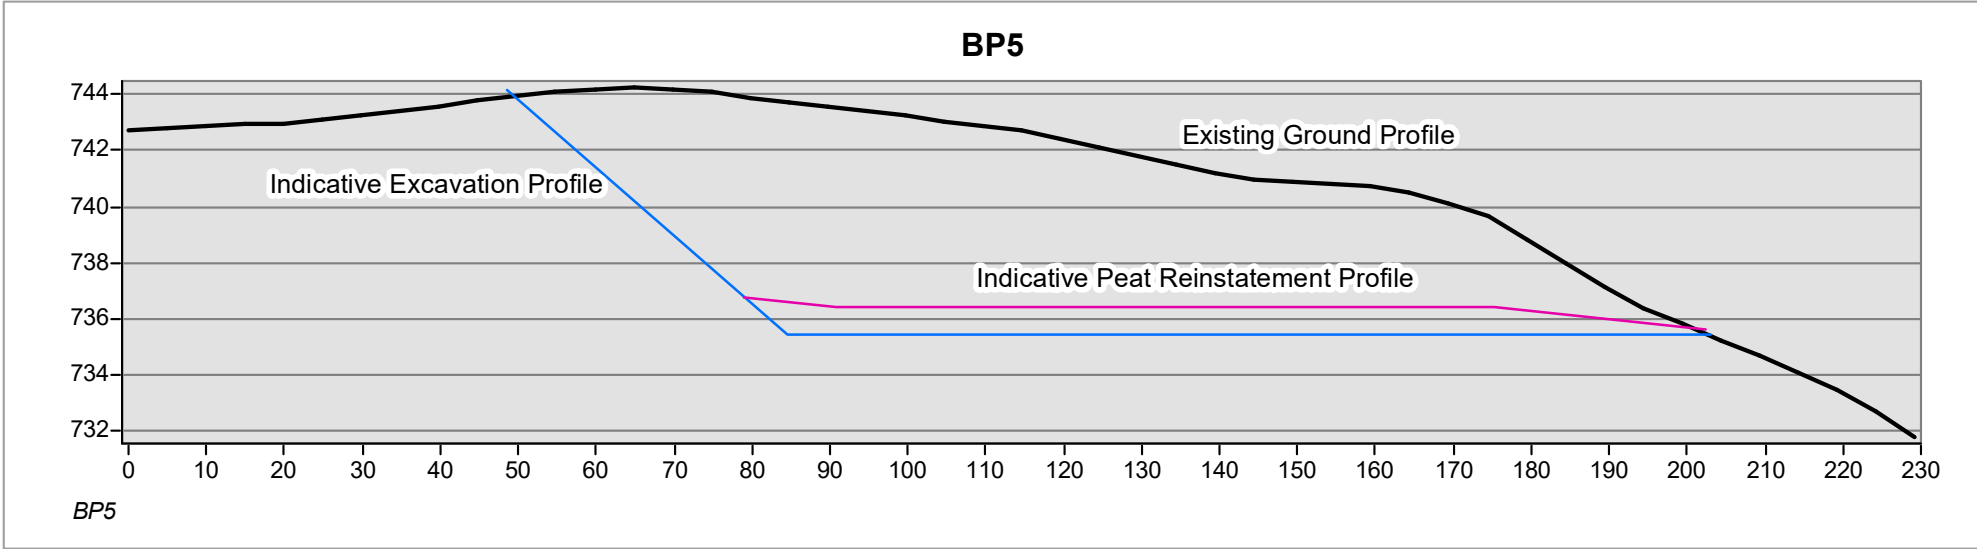
Figure A.6
Borrow Pit Appraisal
Borrow Pit 5

Borrow Pit	Coordinates		Approx. Dimensions					Potential Volume Extracted (m3)	Potential Useful Aggregate	Geology
	Easting	Northing	Search Area (m2)	Width (m)	Length (m)	Max. Depth (m)	Footprint Area (m2)			
BP5	24958	80074	22,500	150	150	16	20,100	147,000	152,880	Granodiorite

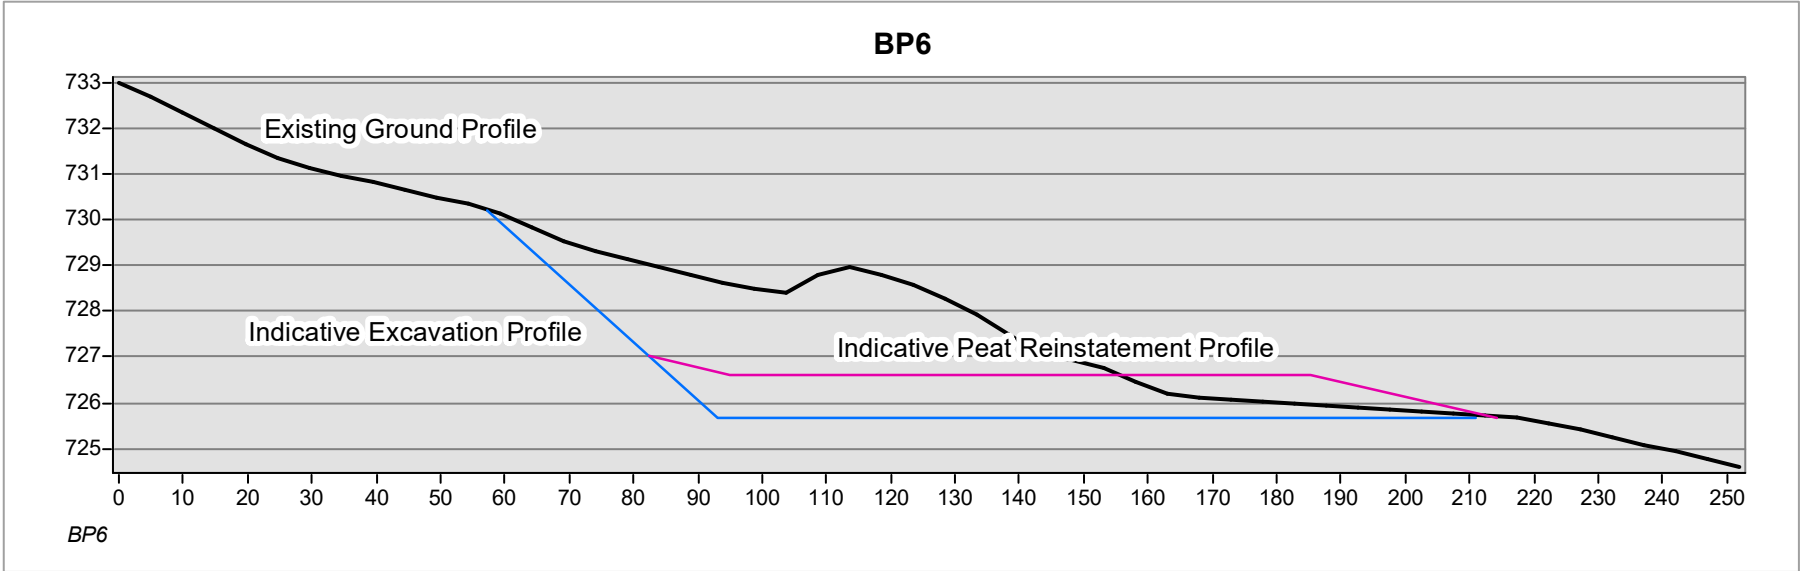
Borrow Pit	Coordinates		Approx. Dimensions					Potential Volume Extracted (m3)	Potential Useful Aggregate	Geology
	Easting	Northing	Search Area (m2)	Width (m)	Length (m)	Max. Depth (m)	Footprint Area (m2)			
BP6	25645	80415	22,500	150	150	5	21,750	38,000	39,520	Granodiorite

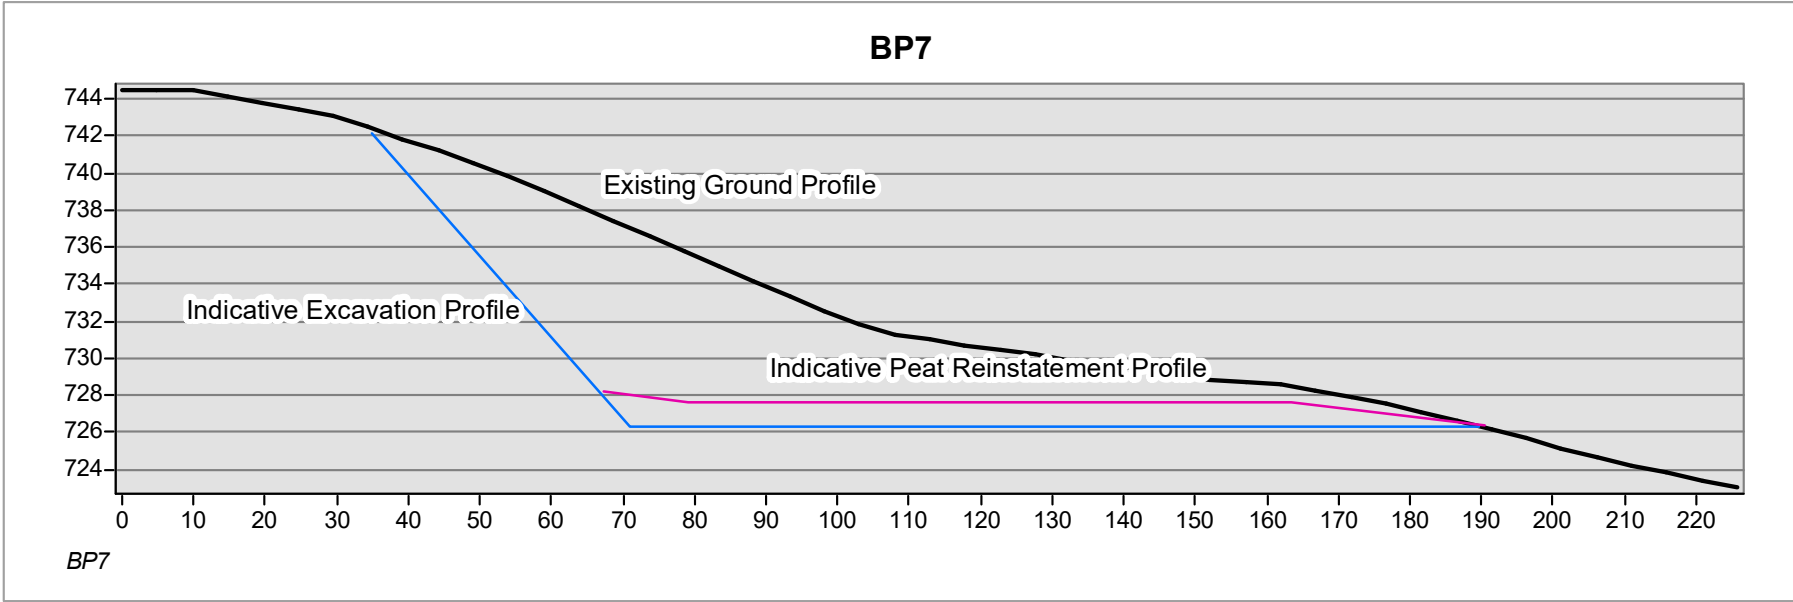
MMD-408095-DR-BP-GIS-007

Borrow Pit	Coordinates		Approx. Dimensions					Potential Volume Extracted (m3)	Potential Useful Aggregate	Geology
	Easting	Northing	Search Area (m2)	Width (m)	Length (m)	Max. Depth (m)	Footprint Area (m2)			
BP7	25554	80161	22,500	150	150	13	20,550	119,000	123,760	Granodiorite

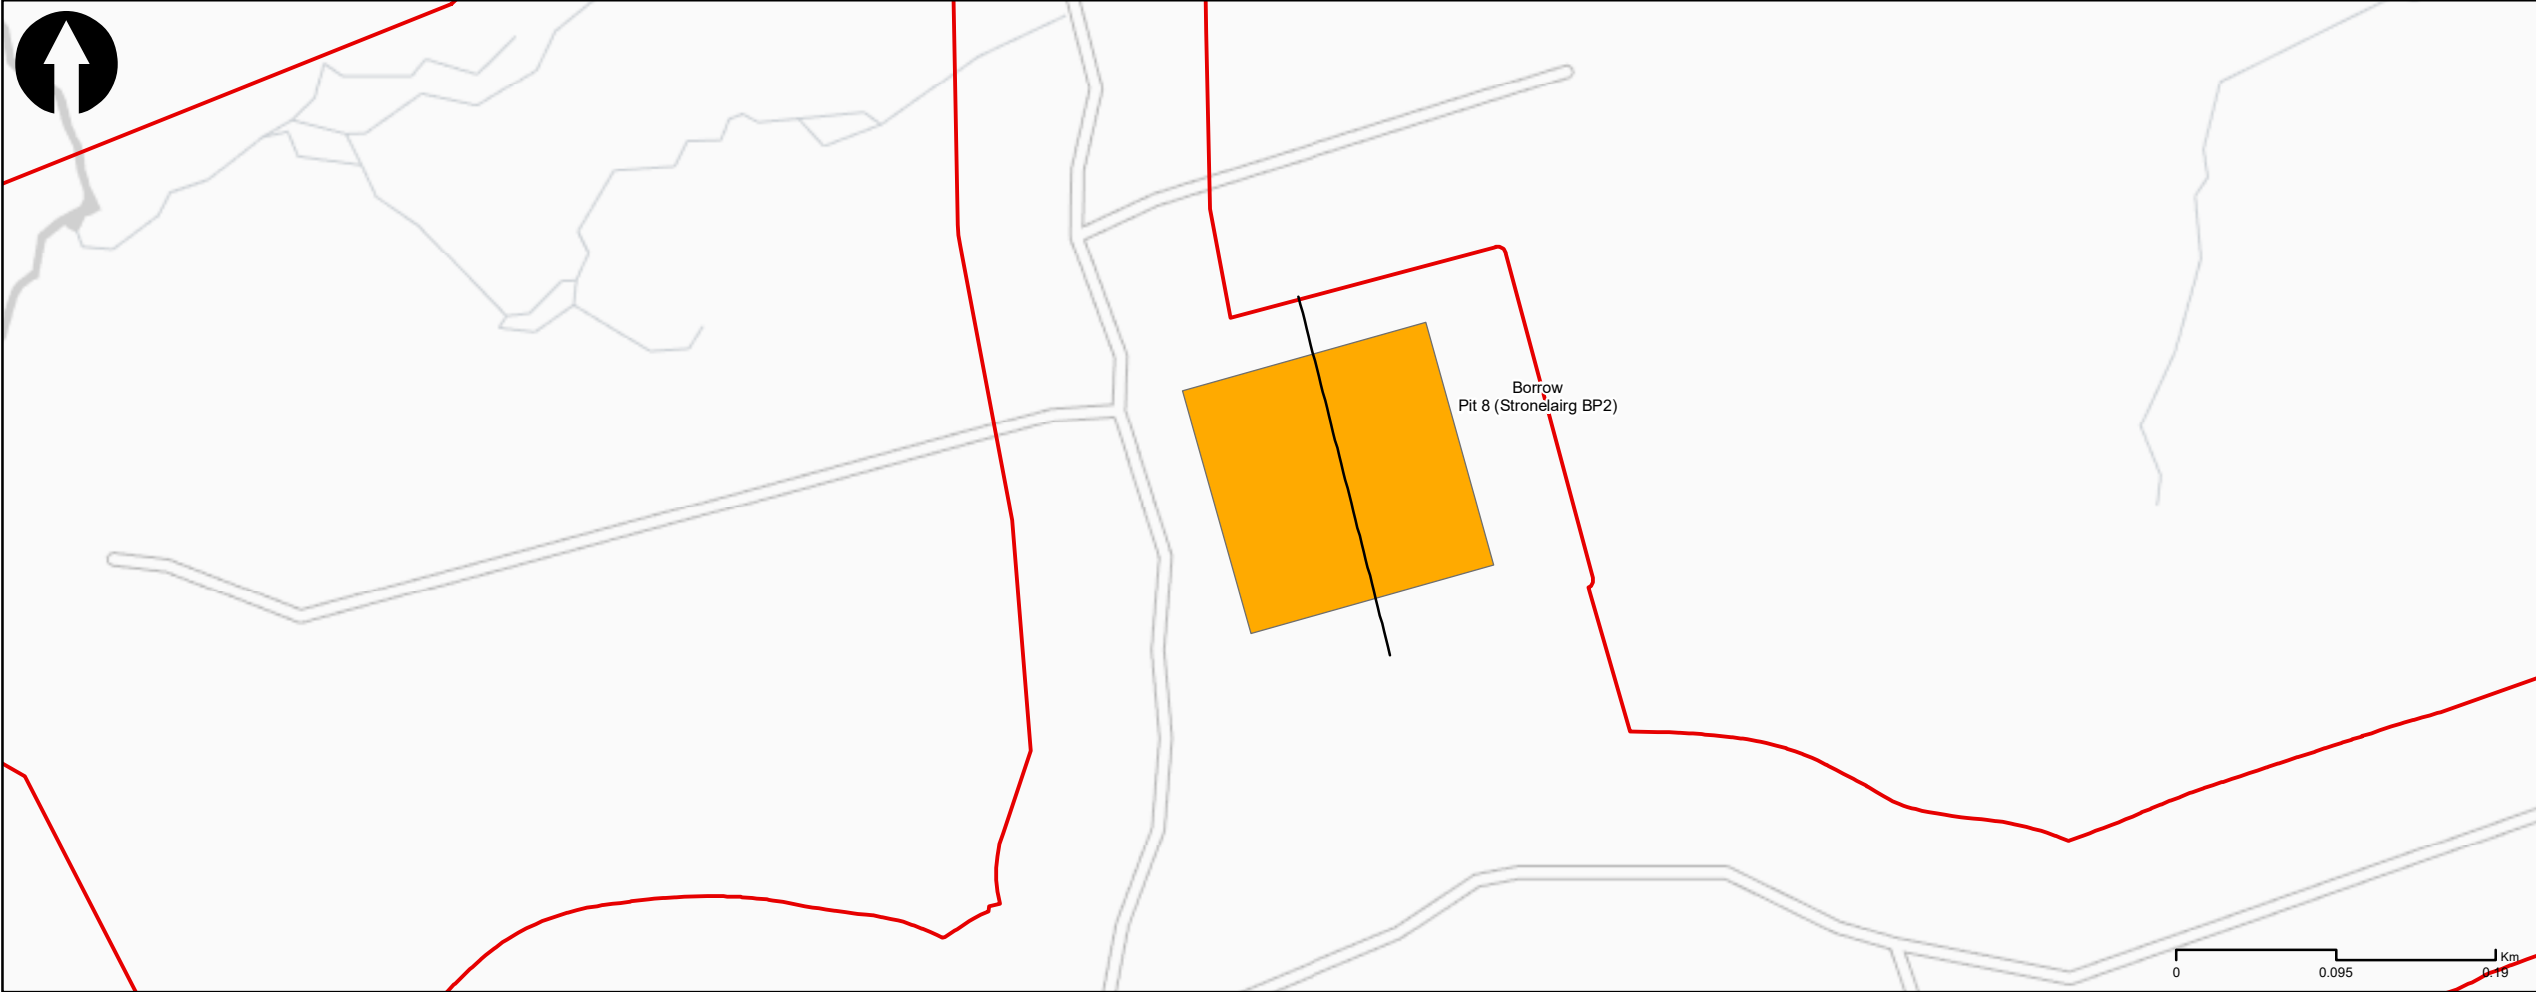
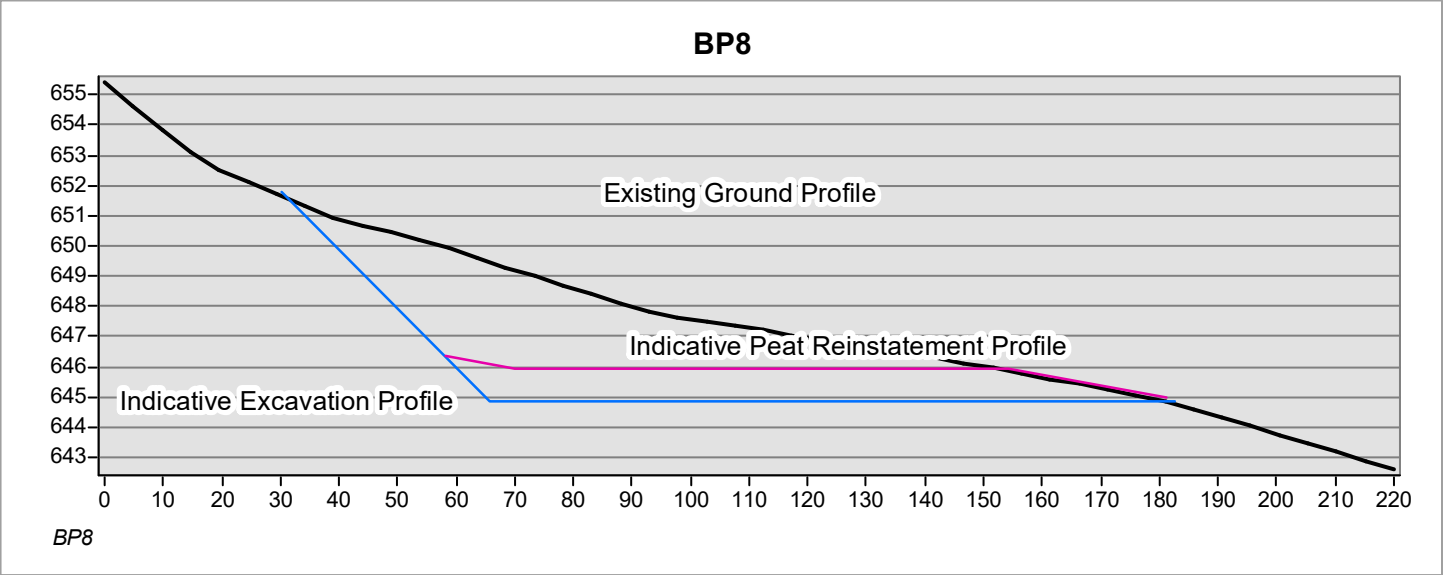
Figure A.9
Borrow Pit Appraisal
Borrow Pit 8

Borrow Pit	Coordinates		Approx. Dimensions					Potential Volume Extracted (m3)	Potential Useful Aggregate	Geology
	Easting	Northing	Search Area (m2)	Width (m)	Length (m)	Max. Depth (m)	Footprint Area (m2)			
BP8	24869	80375	22,500	150	150	6	21,600	49,000	50,960	Psammite

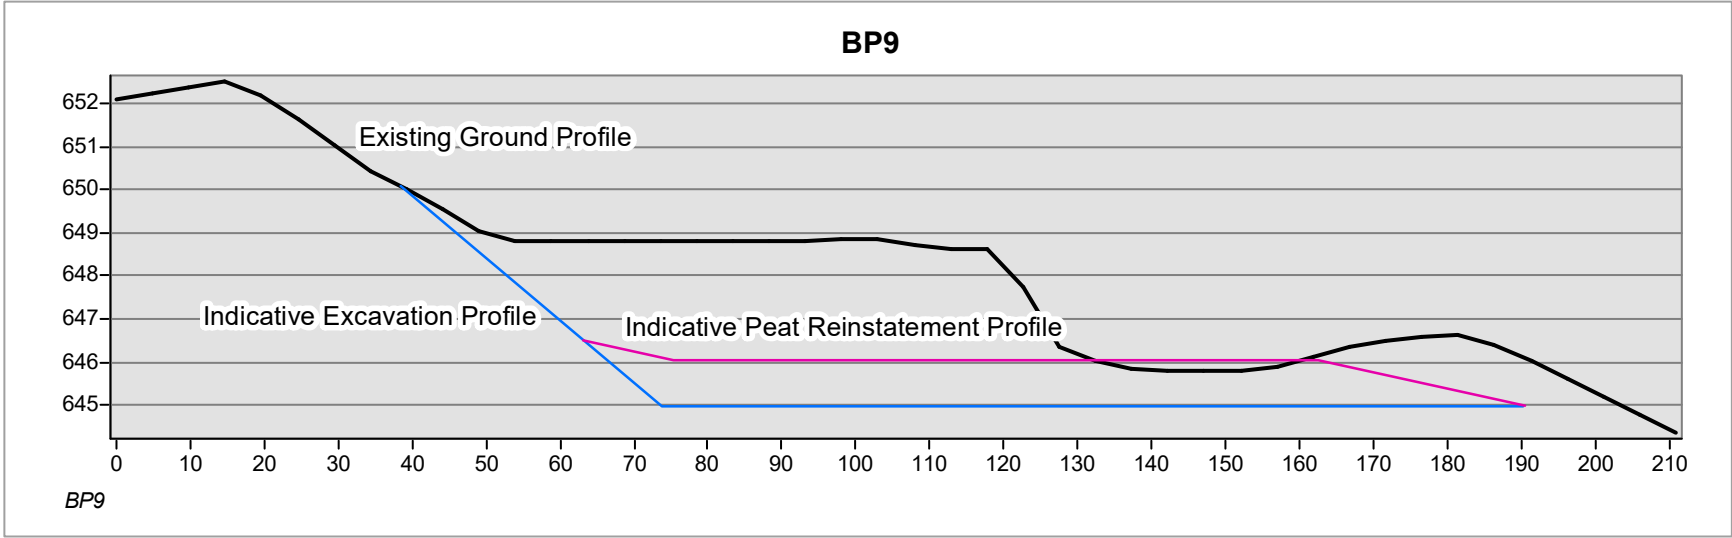
Borrow Pit	Coordinates		Approx. Dimensions					Potential Volume	Potential Useful	Geology
	Easting	Northing	Search Area (m2)	Width (m)	Length (m)	Max. Depth (m)	Footprint Area (m2)	Extracted (m3)	Aggregate	
BP9	25083	80359	22,500	150	150	5	21,750	21,000	21,840	Granodiorite
